# Piping Failure of a Metro Tunnel Construction

Lee, Wei Feng; Ishihara, Kenji

**ABSTRACT:** In this paper, the forensic investigation of a subway tunnel construction failure occurred in Kaohsiung, Taiwan is presented. The studied construction failure occurred during a cross-pass tunnel excavation of a shield tunnel construction work of the Kaohsiung Mass Rapid Transit system, and had resulted in severed tunnel collapse and extensive ground failure that even reached to ground surface 30m above the tunnel depth. In order to investigate such a serious construction failure, particular soil testing programs and geophysical testing methods were carried out to access the possible failure scenario of the investigated case. Information presented in this paper is hoped to be helpful to improve engineers' knowledge for preventing similar construction risks.

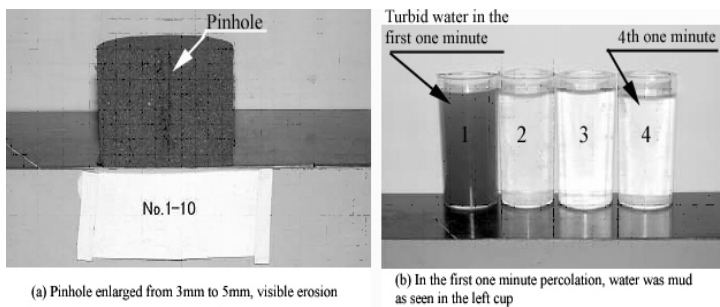
In the first series, the tests were conducted on disturbed samples, one from Kaohsiung and another from Japan. The result of the pinhole tests on a disturbed sample is presented in Figure 17. For the disturbed silt-containing sand sample from Kaohsiung, the pinhole is seen enlarging to a diameter of 5mm from 3mm as displayed in Figure 17(a). Correspondingly, the drained water from the bottom was muddy for the first one-minute period of water percolation as seen in the water colour in the left-side cup of Figure 17(b). The result of the pinhole test on the Japanese silty sand is shown in Figure 18. In contrast to the Kaohsiung soil, the circulation of water through the Japanese soil did not exhibit any appreciable change in colour in the first one minute of percolation as seen in Figure 18(b). There was no change in the pinhole diameter for the Japanese soil before and after water permeation except for a local collapse at the top. Thus, it may be conclusively mentioned that the silty sand from Kaohsiung is potentially susceptible to internal erosion as compared to the soil from Chiba, Japan, although they had almost the same grading. This is believed to stem from the highly non-plastic nature of the Kaohsiung silt contained in the sand.

Figure 17. Silt-contained sample from Kaohsiung

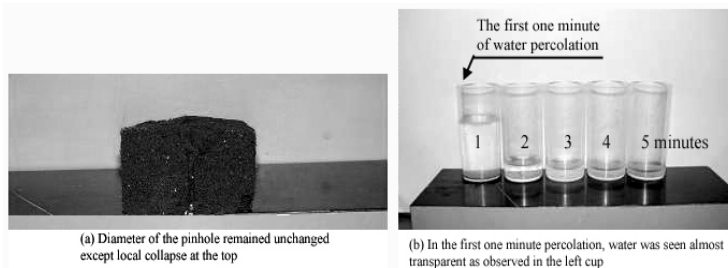
Figure 18. The results of the pinhole test on the Japanese silty sand
